Process Compensated Resonance Testing JT8D-219 1st Stage Blades

September 24th, 2008

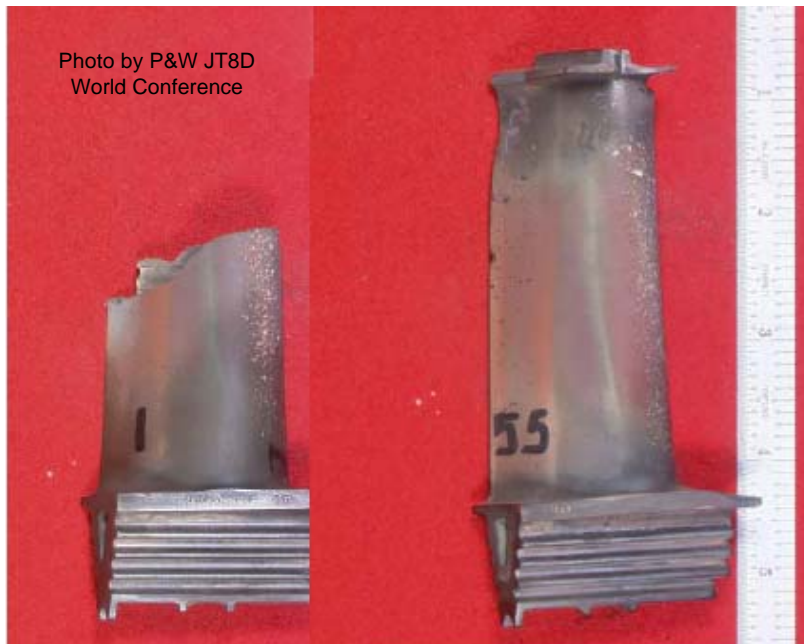
BACKGROUND/HISTORY OF JT8D 1ST STAGE TB

- In service failures caused by:
 - Overtemp
 - IGA
 - Thin wall
 - Stress rupture
- Over 150 blade fracture events reported by P&W since 1990
- Only inspections are UT wall thickness, visual/dimensional/FPI for cracking
- Poor method of determining if over-temped
 - 1/64 blades sectioned per P&W manual
- No practical inspection for IGA
- 24,000 cycle limit and 2-strip limit to avoid future failures
 - No lifetime tracking
 - Not a serialized component,
 - Service markings are inconsistent

JT8D 1st Stage Blades are cause of UER and in-service failures

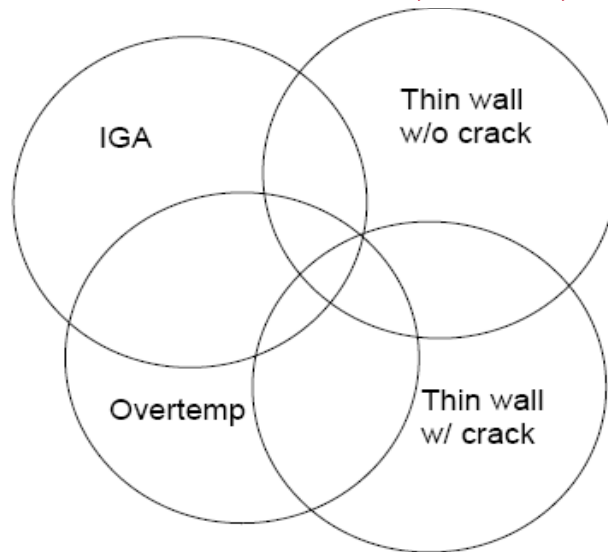
- Probability of Detection (POD) for each defect type must be accounted for
- Each blade could contain none, some, or all defects

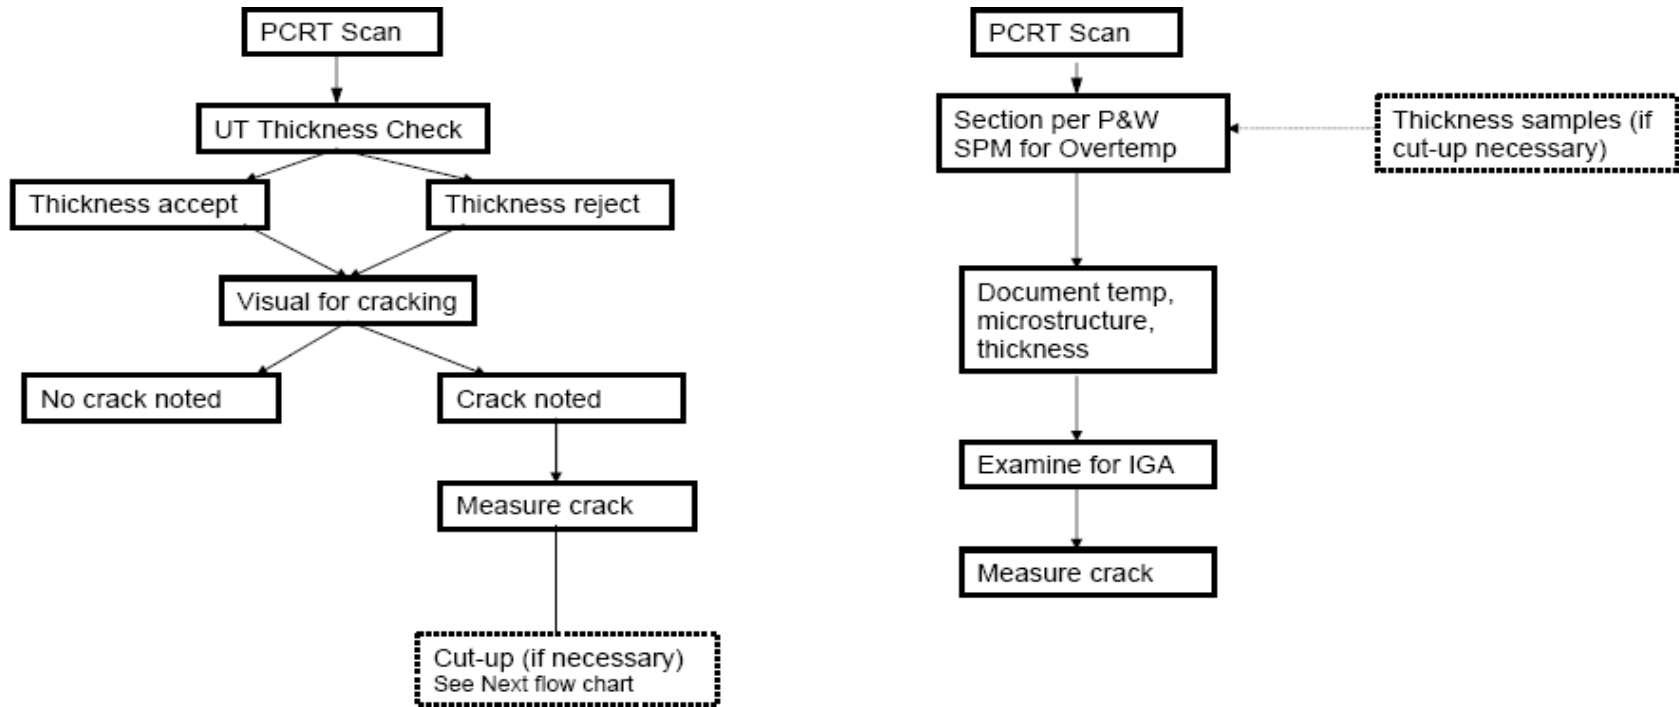
Well thought out plan of attack

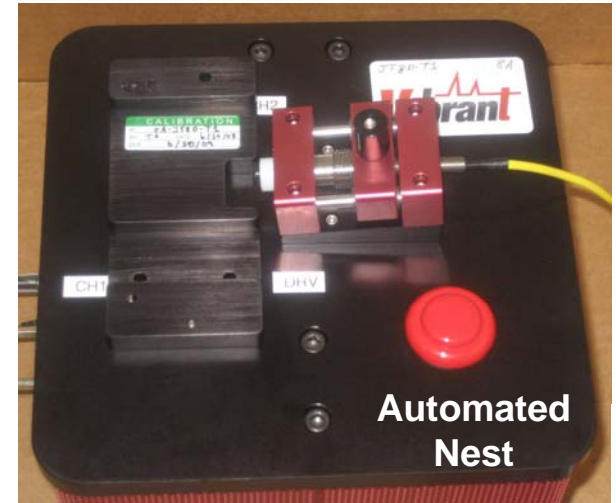
Process Compensated Resonance Testing with Vibrant Corporation fixed nest

- Teaching Set of 89 blades of varying conditions
- Custom Automated Nest with transducer alignment tool built
- Initial Sorting Module developed
 - Sorting Module is being updated as results are confirmed
- Delta employee trained on using PCRT System for data collection and provided with detailed Work Instructions
- Vibrant continues to support to ensure proper data collection

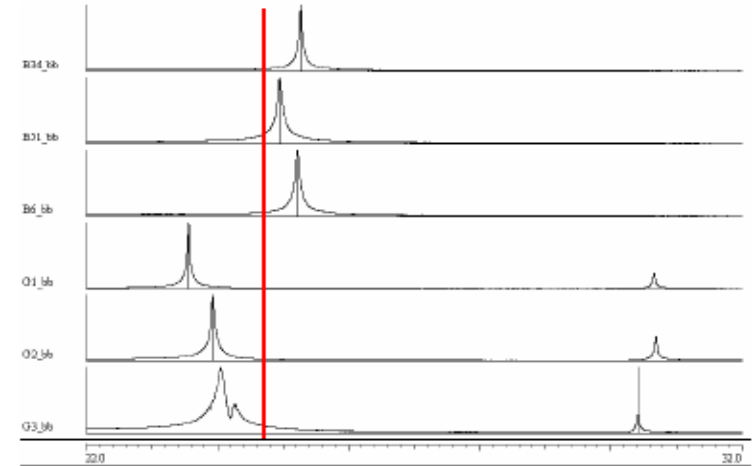
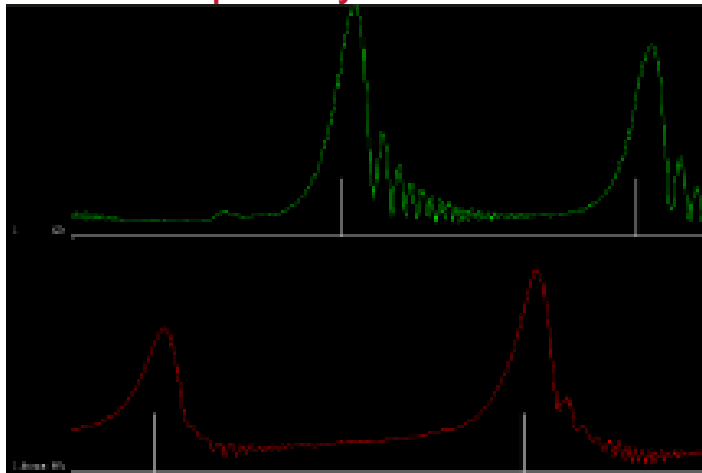
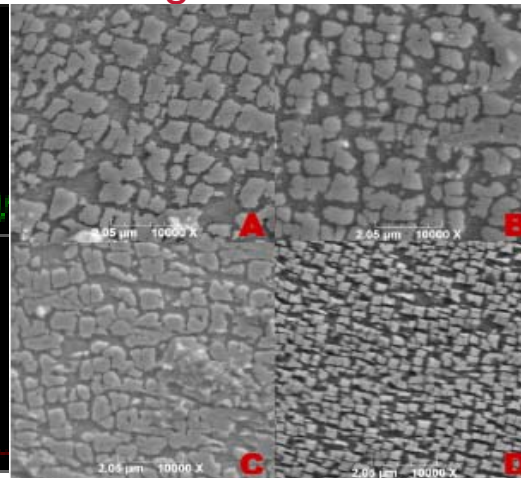
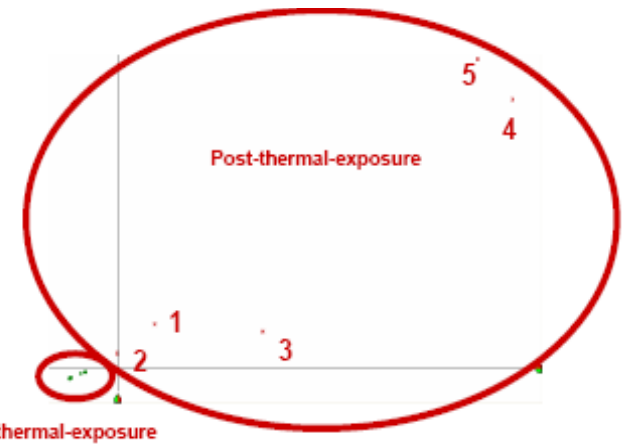
- Internal Vibrant study
 - JT8D 3rd stage turbine blade
 - Various temperature exposure
 - Peak shift, relative spacing change (gamma prime solutioning)
 - New peaks created, some peaks disappear
- Capability for microstructure change shown

PCRT has shown capability to sort based on overtemp criteria

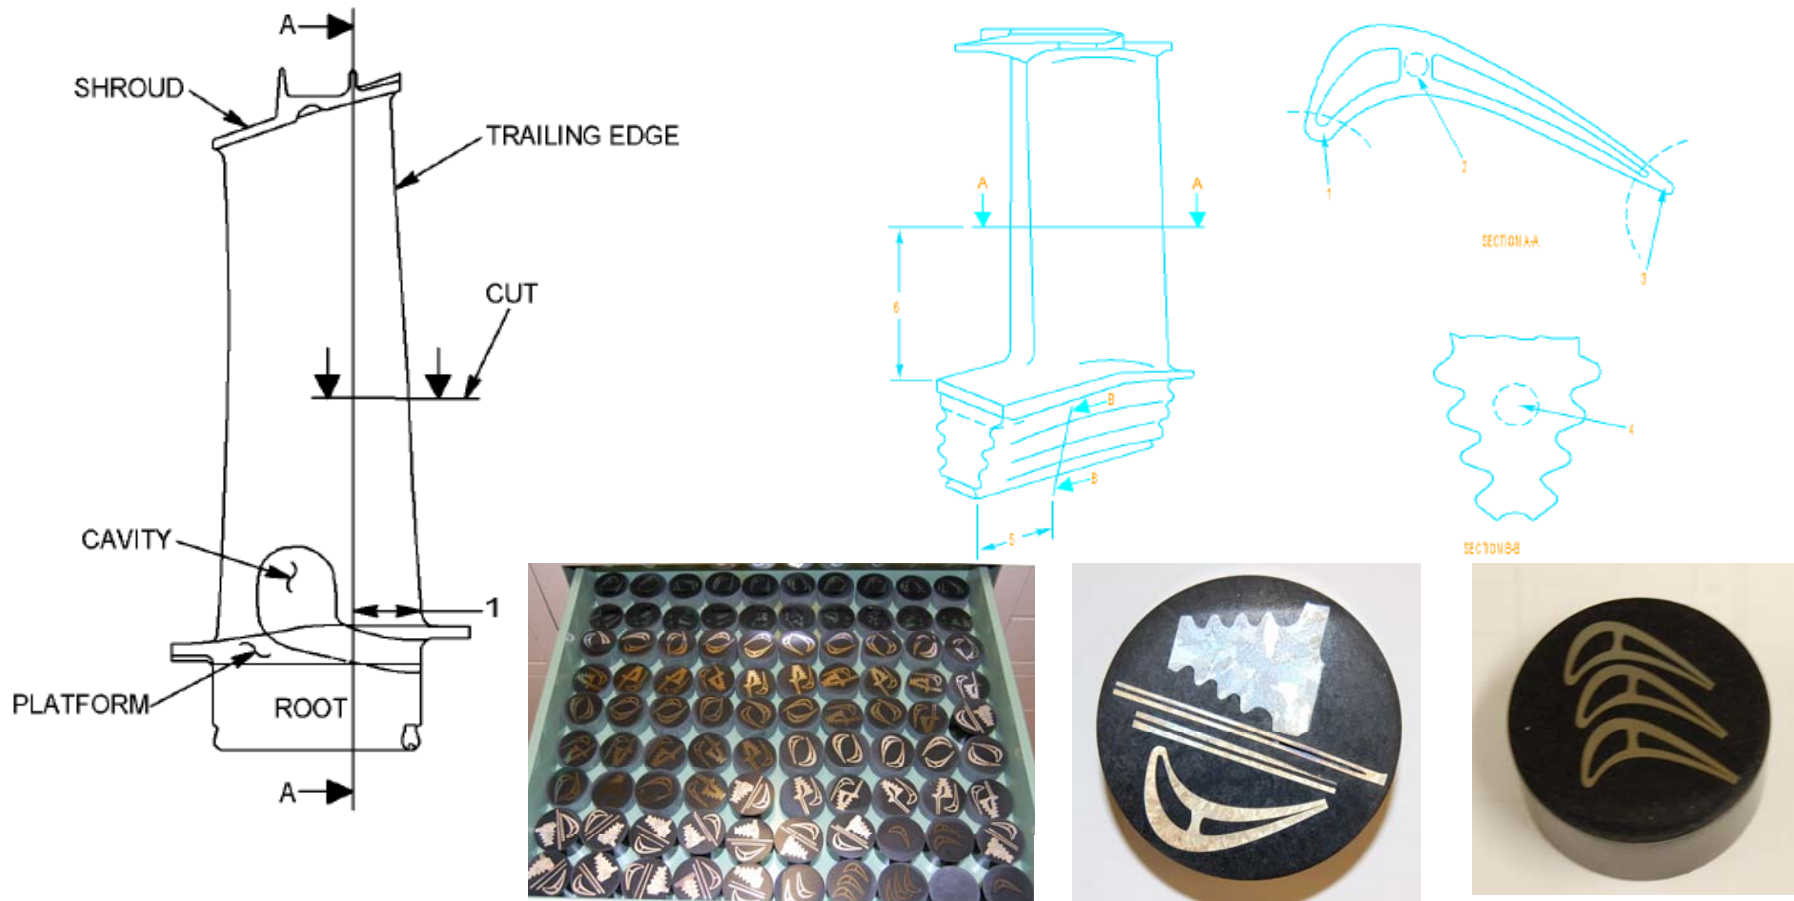
P&W SPM OVERTEMP ANALYSIS

P&W Overtemp analysis requires destructive testing of 1 blade to determine disposition of entire blade set

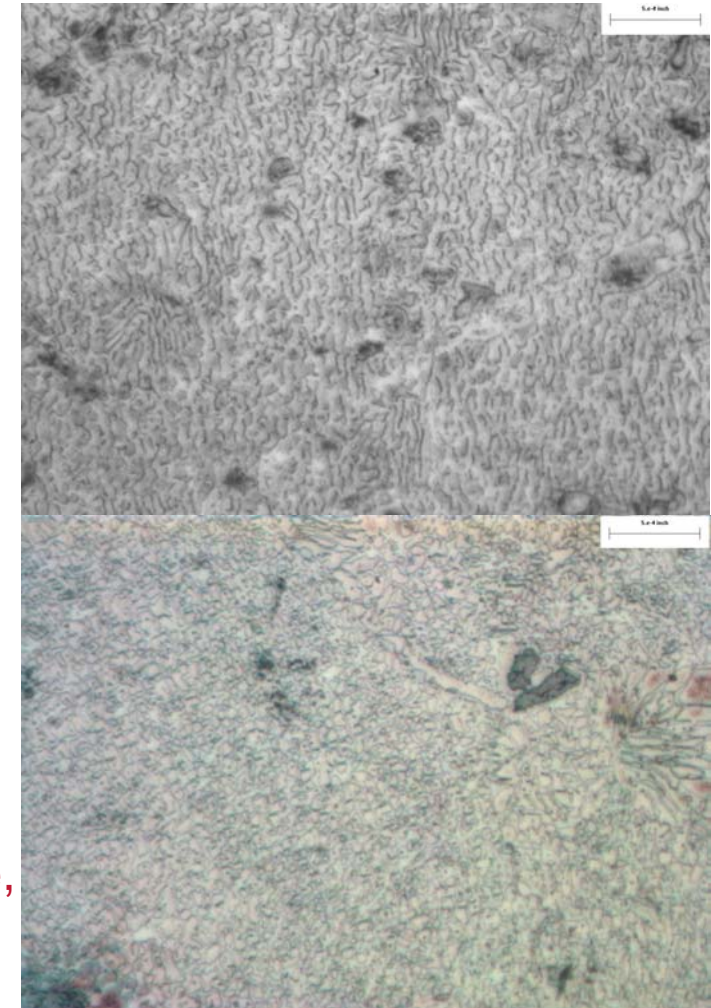
Blade/Vane Temperature:	Blade/Vane Condition
2050°F	Blade/Vane Overtemped

- Blade exhibited rafting, coalescence and rafting of the gamma prime precipitate within parts of the leading edge and in the trailing edge consistent with a blade over-temperature.

Blade/Vane Temperature:	Blade/Vane Condition
Approached 2050°F	Blade/Vane Good

- While there was mild rafting coalescence of the gamma prime precipitate within parts of the leading edge and in the trailing edge of the blade, there was not enough to be considered a blade over-temperature.

PCRT has shown good agreement with subjective metallography req't

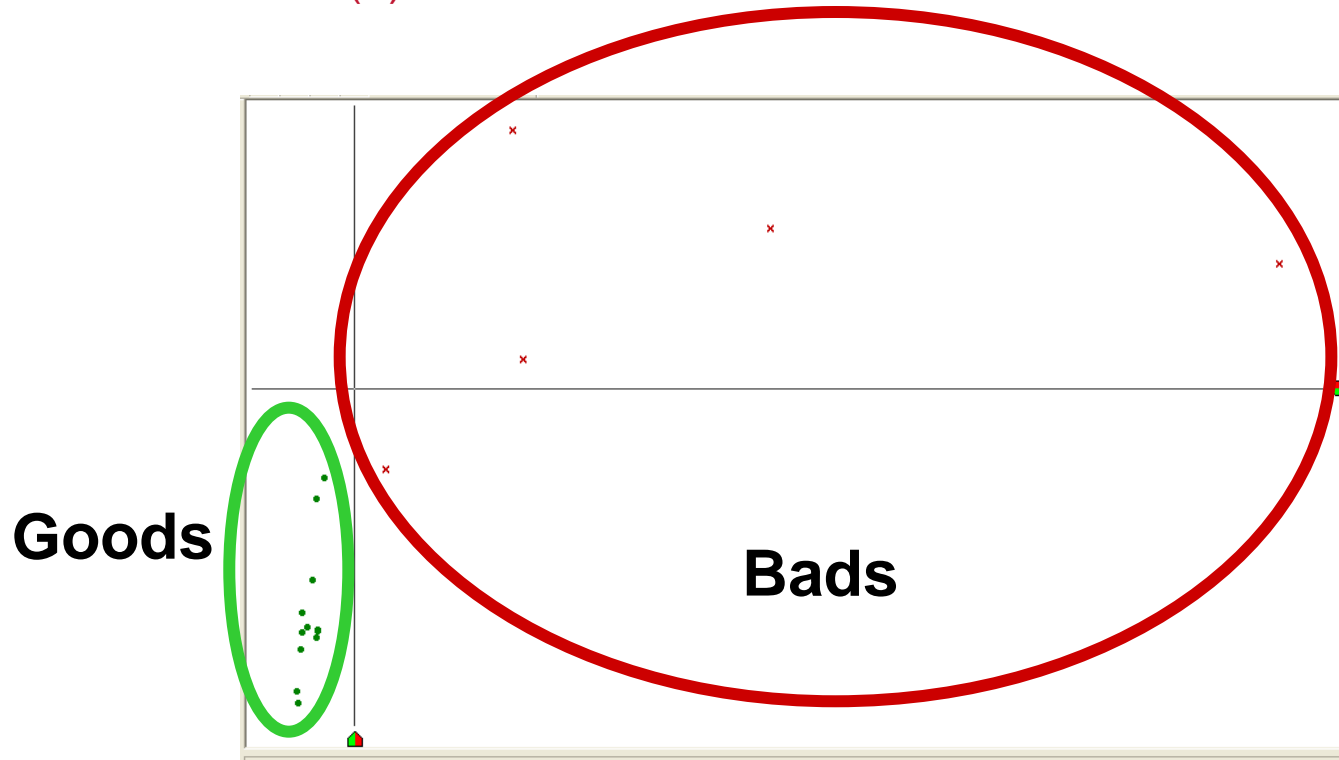
- In service acceptable = Goods (14)
- Overtemp 2050 F = Bads (5)

PCRT sort for overtemp

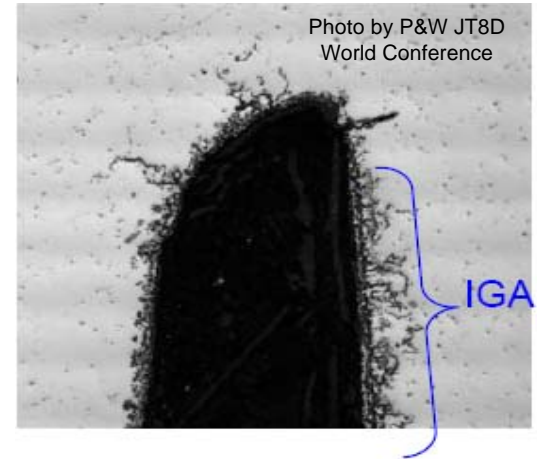
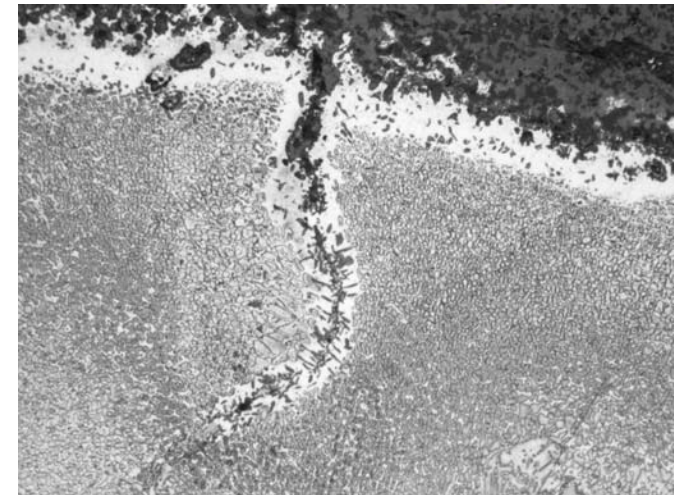
- Intergranular attack
 - Stress rupture – stress, temp, time
 - Blockage of cooling passage, contaminants
 - Coating depletion
 - Localized hot spots
 - Strip & recoat repair – internal cavities
 - Practice ceased, modified
 - Recent failures attributed to IGA/stress rupture
 - No inspection for IGA
 - OEM – spare part sales
- Project will quantify degree of IGA
 - Accept/reject Limits

PCRT has shown capability to detect IGA

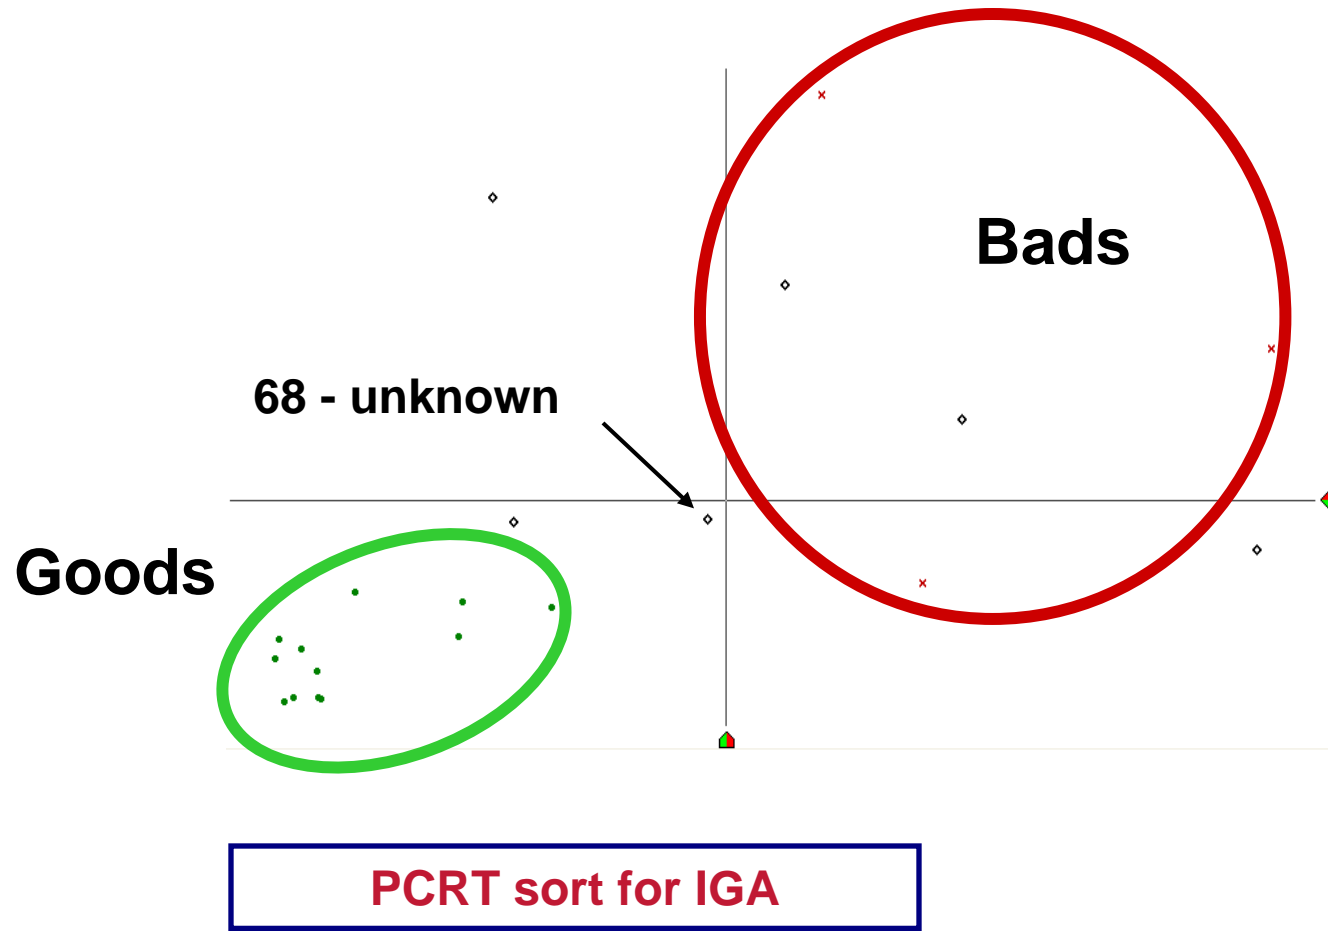
- In service acceptable = Goods
- 2+ stripped (suspect IGA) = Bads

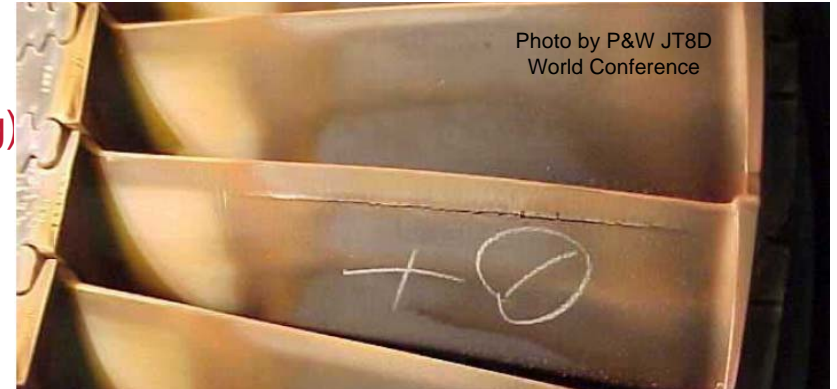
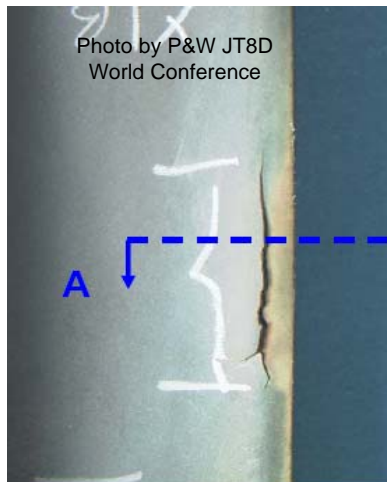
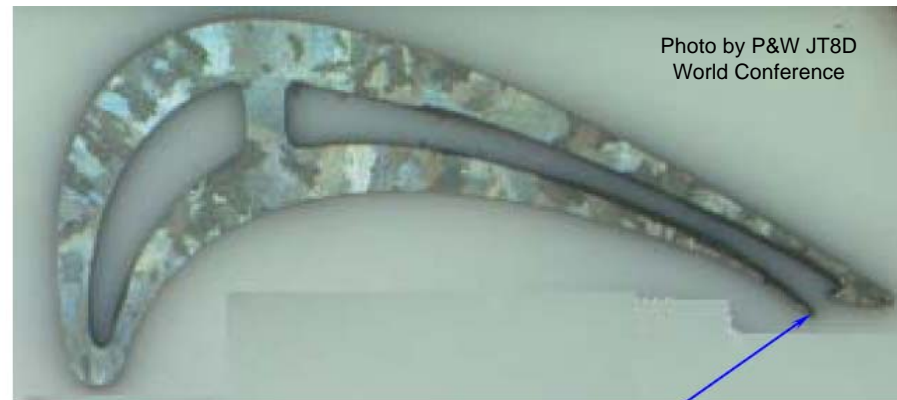
Thin Wall Condition

- Cracking typically on trailing edge
 - IGA cracking
 - Thin wall (parent metal removal with stripping)
 - Some blending operations
 - UT Thickness check
 - Revision coming soon from P&W
 - On-wing borescope findings
 - UERs = \$\$\$\$

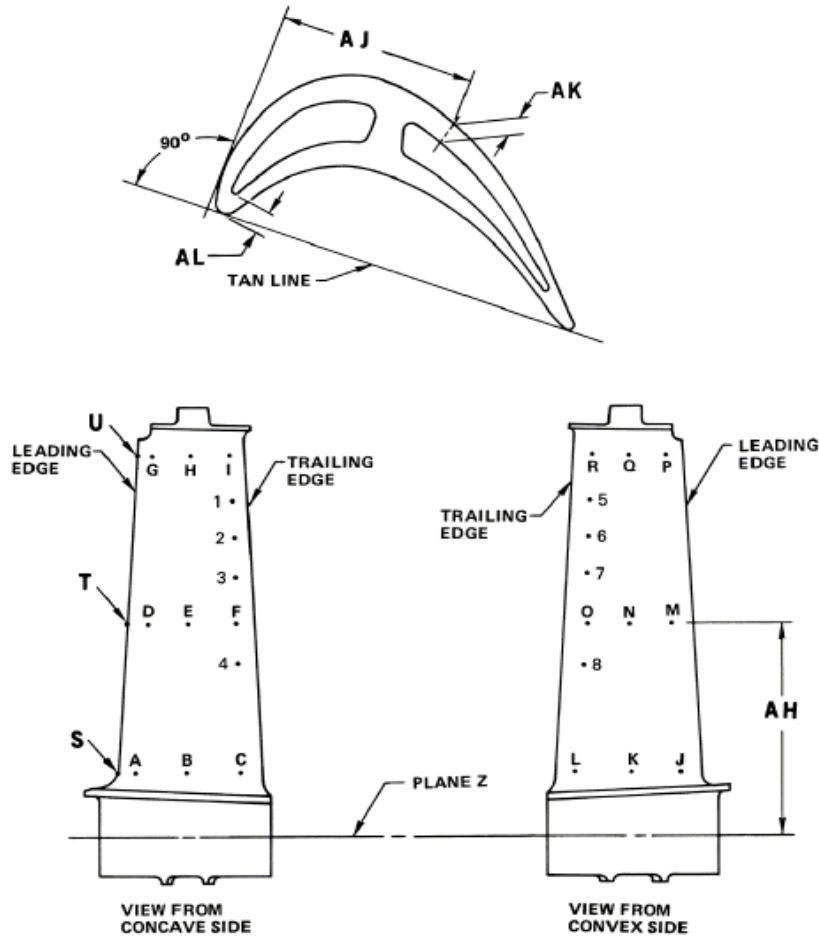
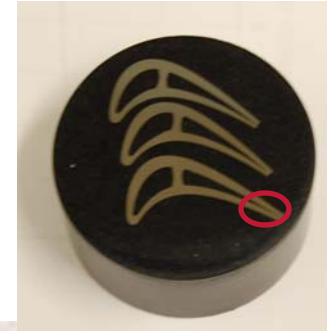
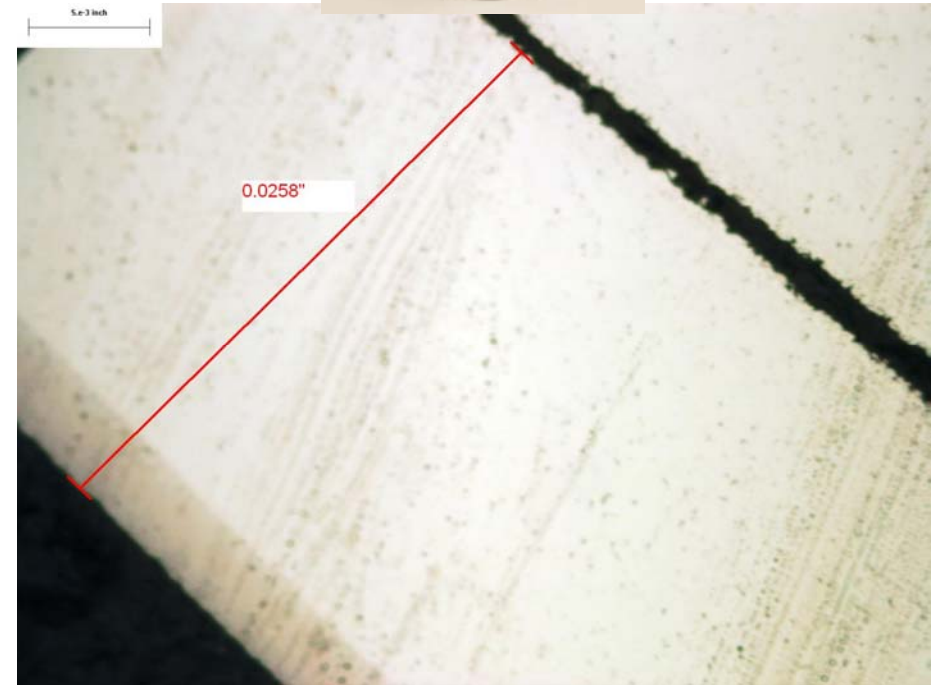
PCRT & CRACKING, THIN WALL

PCRT has shown capability to detect cracking, thin wall

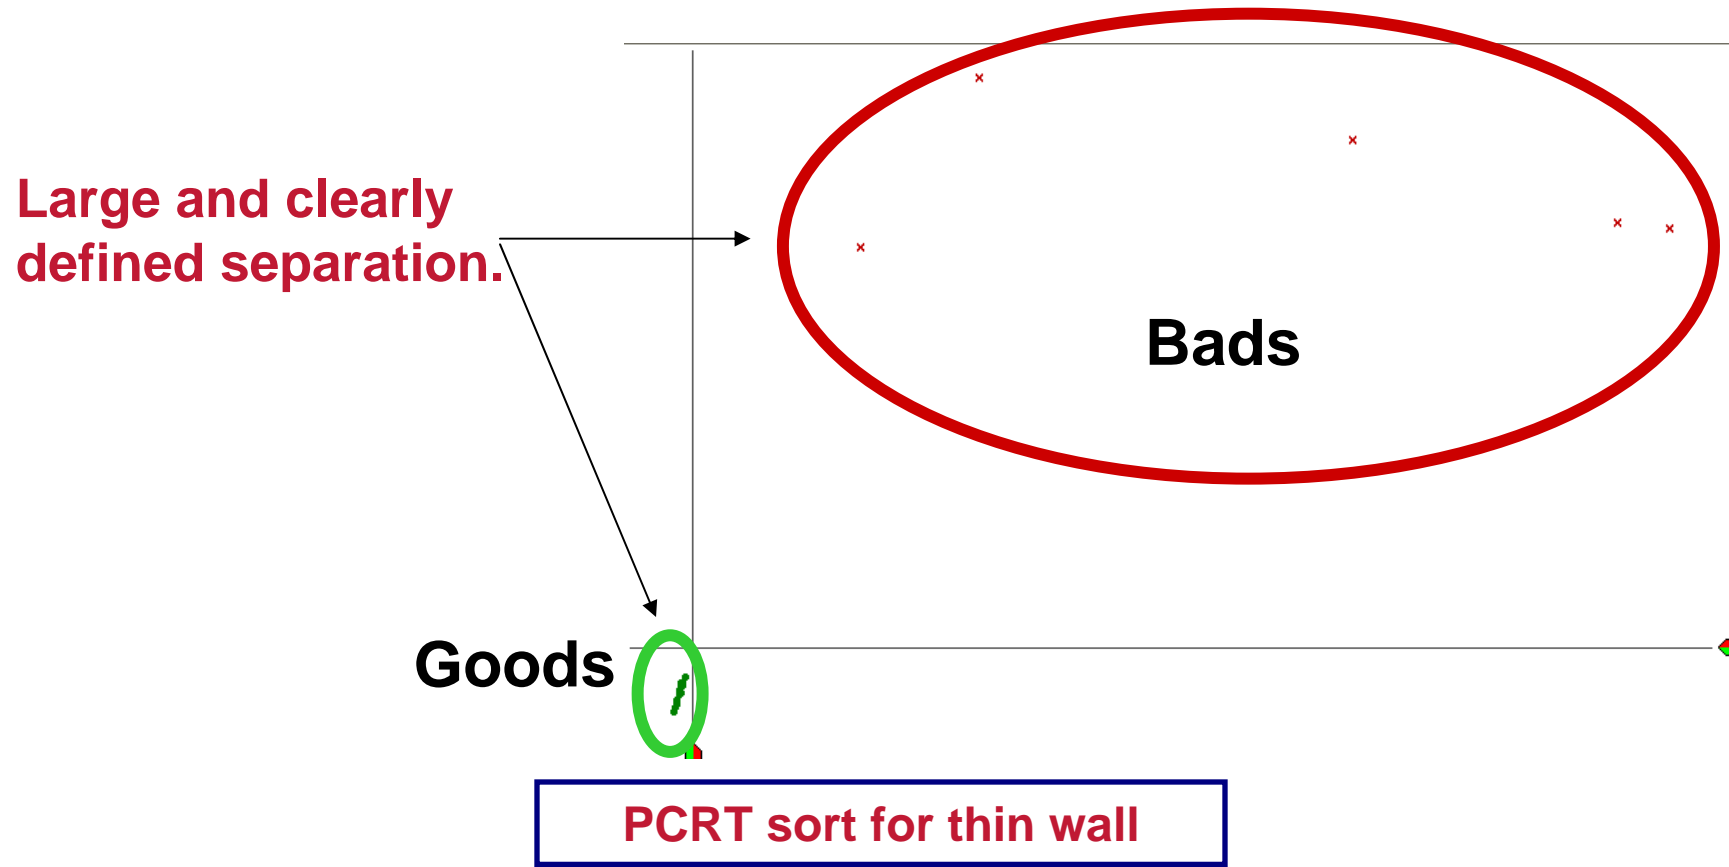
- In service acceptable = Goods
- Cracked/thin wall = Bads

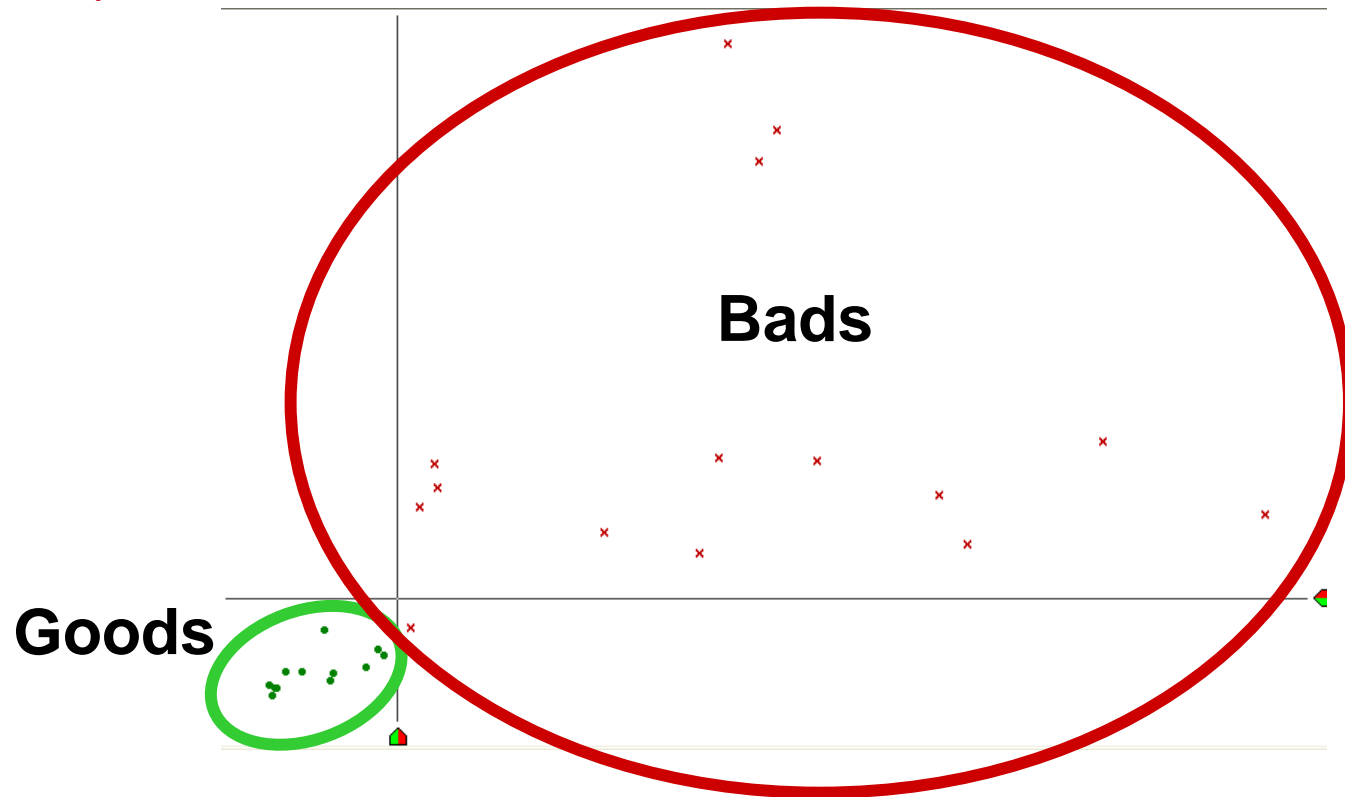
- Reduces robustness of PCRT System, however also reduces sorting time.
 - Only need to perform one check for all defects

PCRT sort for overtemp, thin wall/cracking, and IGA
