2009 Aging Aircraft Technical Paper

Modern NDT for Aging Aircraft

**12th ANNUAL JOINT FAA/DOD/NASA CONFERENCE ON
AGING AIRCRAFT**

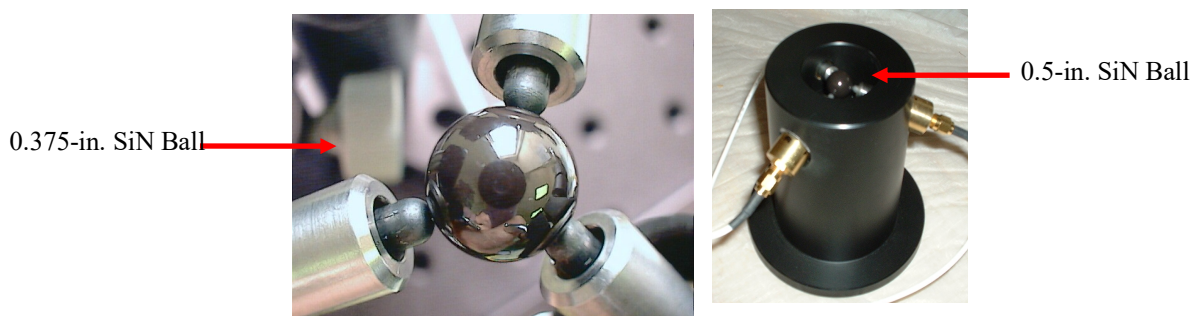
Figure 17 – Nest Designs for Ceramic Balls

The nest designs for some of the ceramic balls studied are shown in Figure 17. The nest for the 0.5-in diameter ball is a fixed nest that improves the repeatability of the PCRT system.

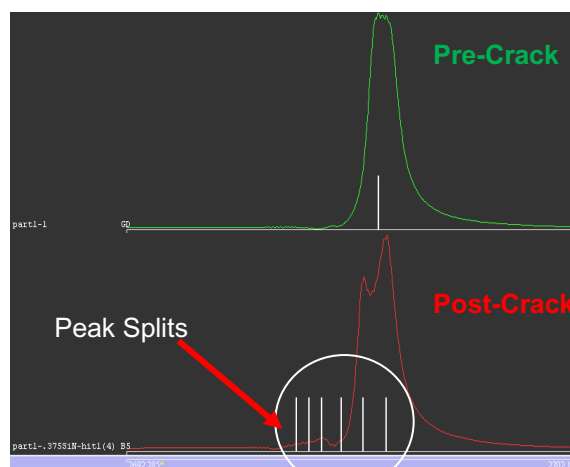
Figure 22 – Resonance Comparison at 2.697 MHz for Pre- and Post Crack 1.125-in. SiN Ball

Smaller surface damage is detectable by higher order surface resonance. Figure 22 shows peak splitting around 2.6 MHz due to a C-spall crack introduced into a 1.125-in. ball (via impact with a 0.375-in. ball).

The 2.697 MHz resonance in Figure 22 has the characteristics of peak splitting with the formation of many new resonances as indicated by the white vertical lines. These characteristics were evident on many other resonances over the broadband range. The peak splitting characteristics were expected based upon the surface acoustic wave behavior described by Migliori [6].

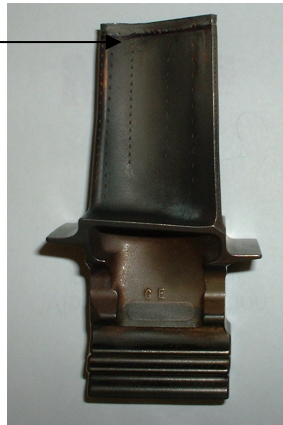
Figure 23- Image of CF6-80A Turbine Blade

The CF6-80A Stage one blade is unique in design, manufactured with a brazed-in inverted tip cap that has led to several service failures and numerous in flight shutdowns. After an undetermined and unpredictable amount of cycles the braze diffusion line is weakened by service stresses. This weak area is a prime location for crack propagation when the part is under load. Once a crack is present, it grows along the diffusion line in an axial direction using the parent material and braze interface as a guide. The cracks will grow towards the leading edge until they break out to the surface. After breakout, the crack and surrounding parent material is subjected to the harsh operating environment of the high pressure turbine. This allows the corrosive elements to attack the exposed material and eventually a complete tip separation can occur. These failures have occurred at unpredictable cycles and hour intervals. This unpredictability lead Delta Airlines to self impose an 11,000 hour life limit on the blades, resulting in a sequestering of over 1,500 possibly serviceable blades.

**Brazed-in
Inverted Tip Cap**

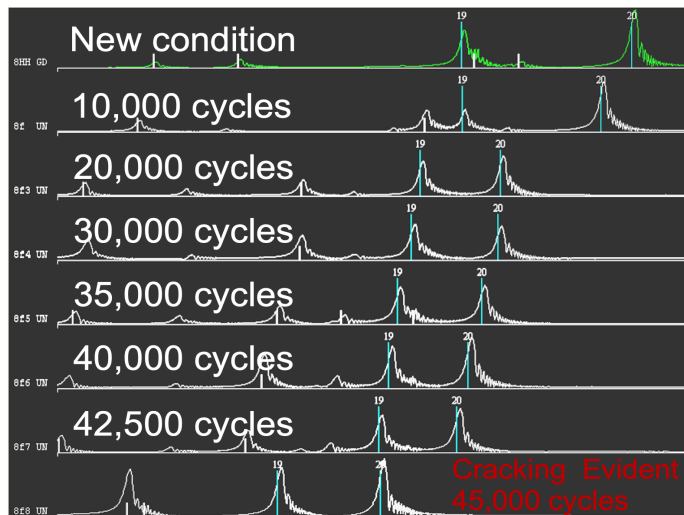
Figure 30 – Spectra of Al 6061-T6 Coupon Showing Shifting due to Fatigue

Spectra was captured between load cycles at regular intervals. A portion of the spectra from a coupon is shown in Figure 30.

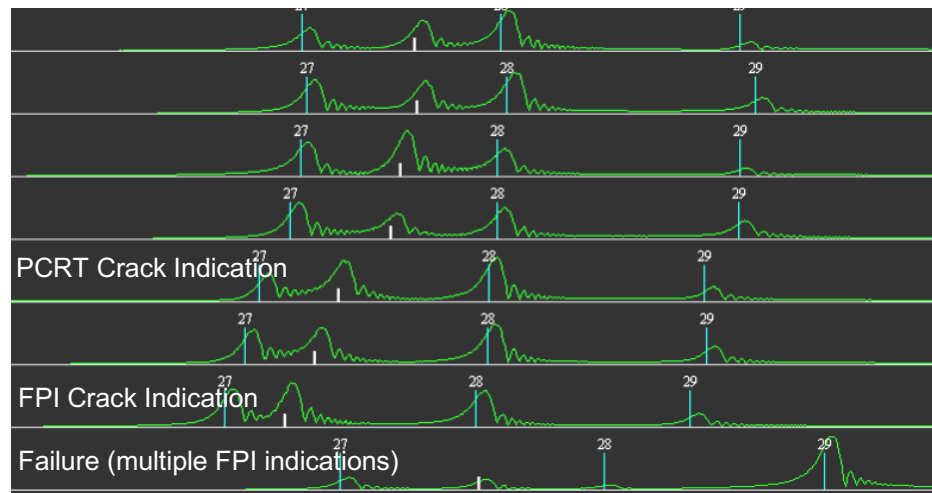
Figure 33 – Rene 80 Coupon Resonances Indicating Fatigue

Periodically, the coupon was logged with the PCRT System. It was also inspected for any geometrical changes and discontinuity nucleation or propagation. Dimensional, visual, and fluorescent penetrant inspections were performed to correlate the resonance spectra to physical changes. A typical test is demonstrated in Figure 33. The crack is indicated through PCRT by the increased frequency shift and change in relative spacing (peak convergence). Notice that PCRT has the capability of detecting cracking prior to FPI indication.
